COLLIERVILLE SCHOOLS

RE: Response To Violations-TN Individual Construction Permit Tracking Number: TN0081787

Collierville Schools Response to Required Actions:

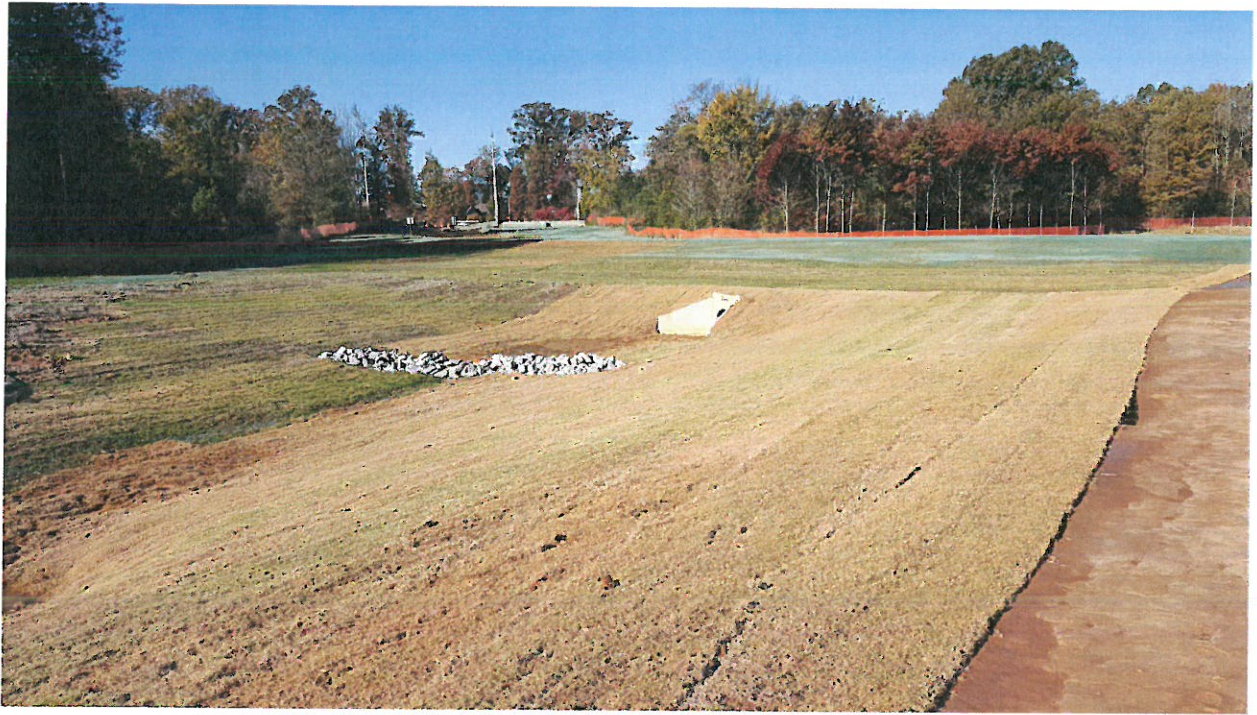
Photo 1 Area adjacent to middle entrance from Sycamore Road. All rills have been graded and area stabilized with permanent sod.

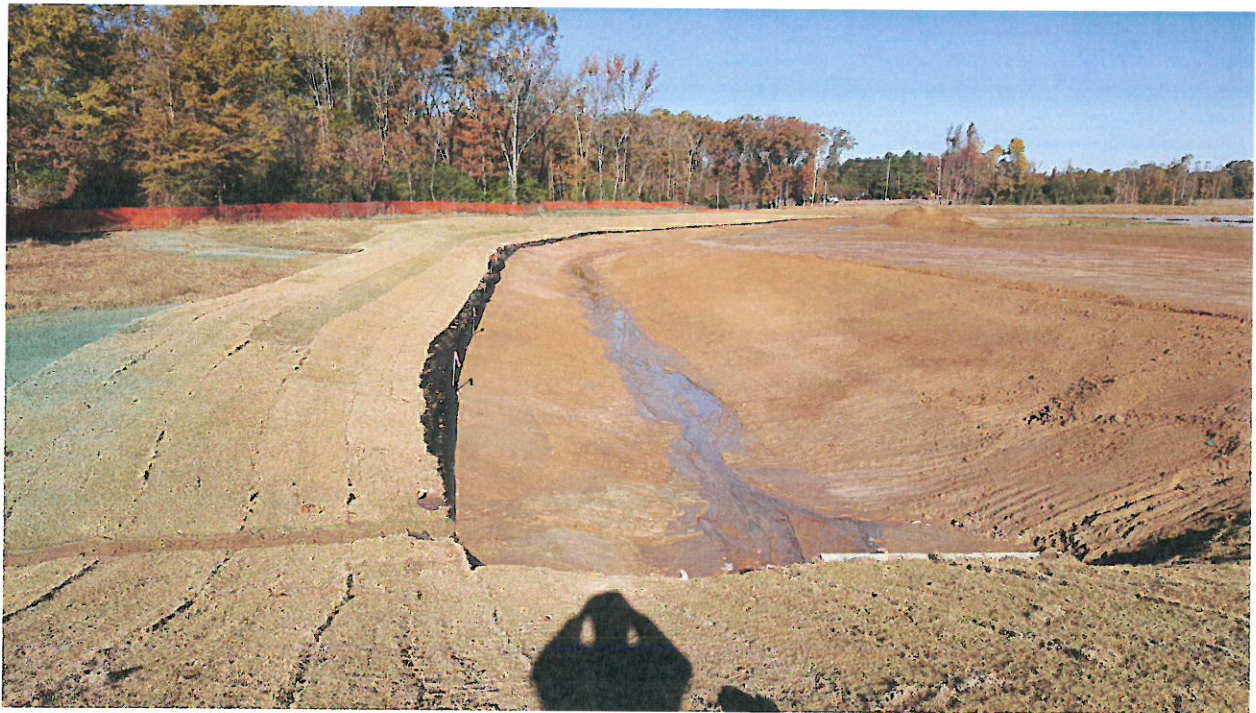
Photo 2 Area adjacent to middle drive off Sycamore Road on the North side. Back slope stabilized with sod and hydroseed behind sod. Flow line is to grade and will receive 8 foot concrete swale.

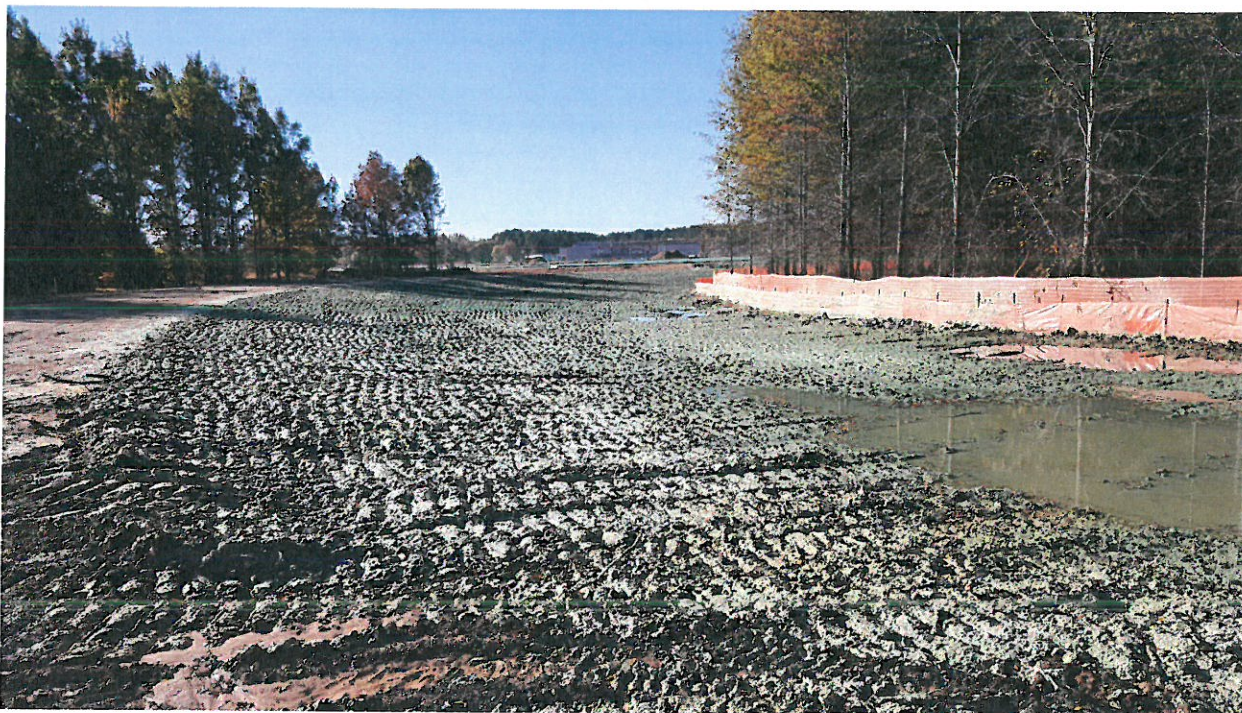
Photo 3 Middle entrance off Shelby Drive. Grading complete and area stabilized with Flex-terra.

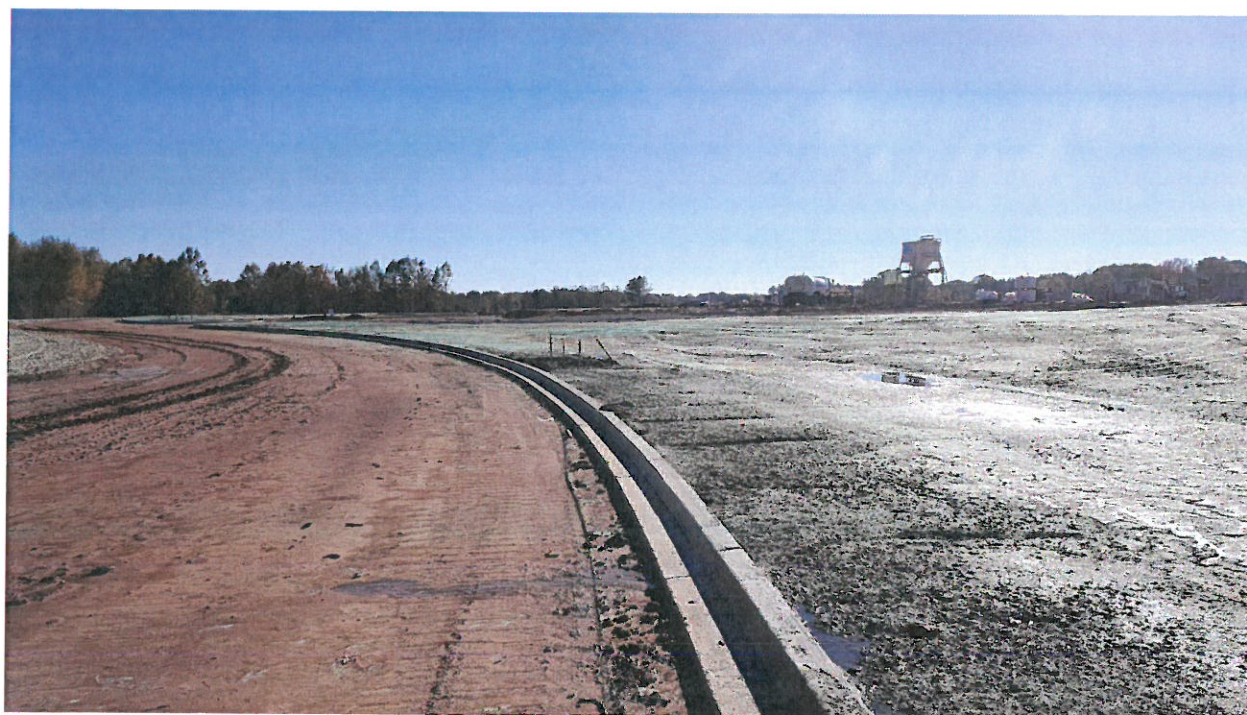
Photo 4 Middle entrance drive off Shelby Drive. Curb and gutter installed. Grading in front of the building is complete and stabilized with Flex-terra.

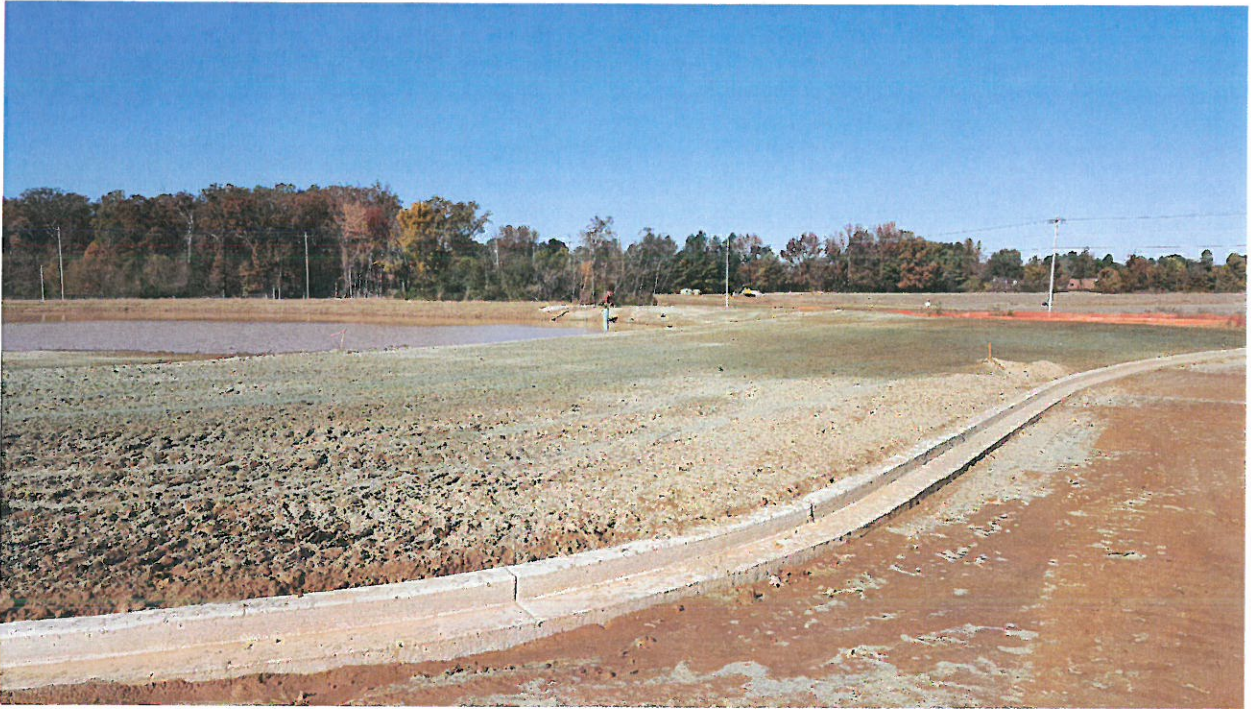
- Depth gauges were not installed in the NW and NE basins due to poor communication between the General contractor and the subcontractor over whose responsibility it was to place the depth gauges. However, Reel Neat Erosion Control communicated the limits of ponded water to the Renaissance Group who in turn, calculated the volume of stored water in the basin enabling Reel Neat Erosion Control to apply the correct amount of chemical flocculent to treat the basins.

Photo 5 NW Basin with banks stabilized with Flex-terra.

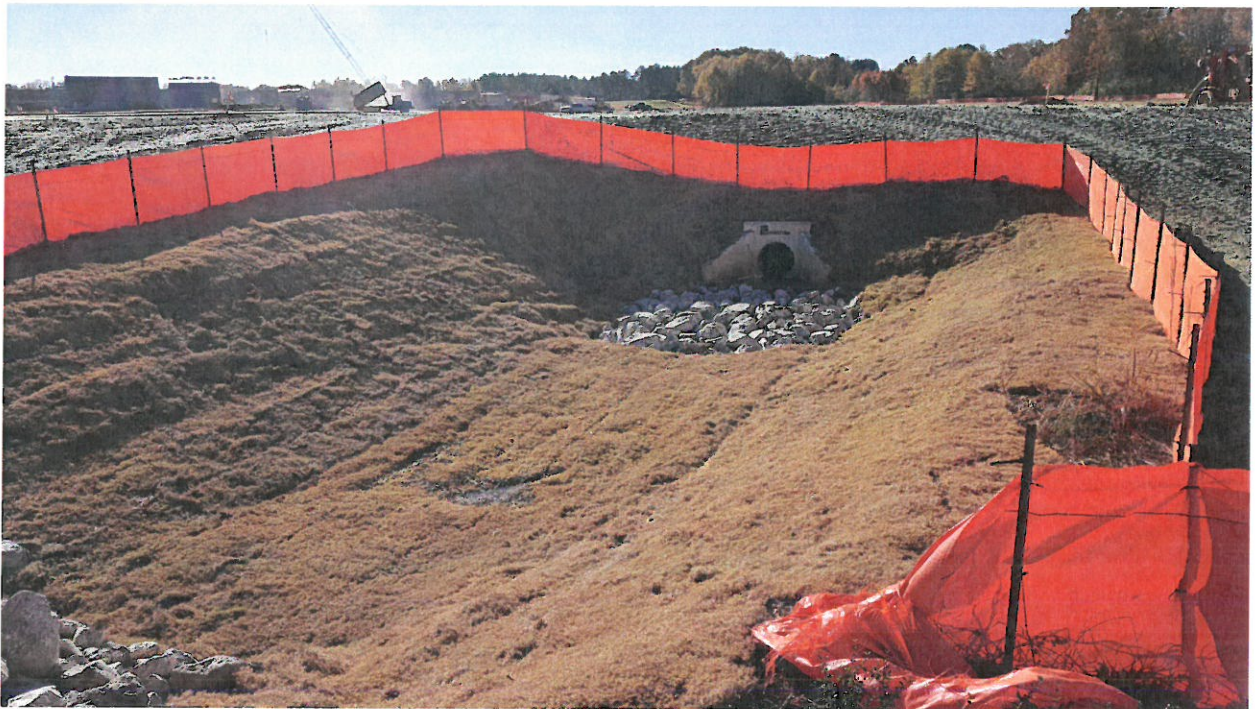
Photo 6 Outfall SW1 at NW basin. Area is permanently stabilized, protected with silt fence, sod, and rip rap.

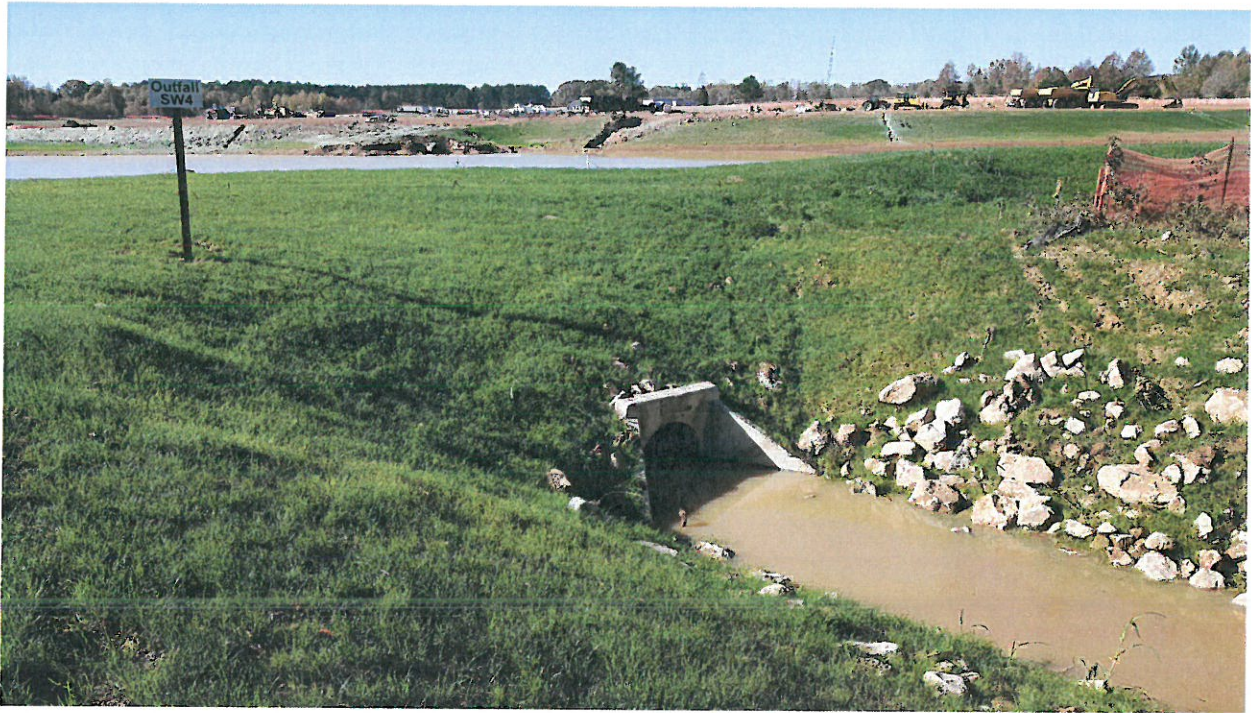
Photo 7 Outfall SW4 has been permanently stabilized. The waters shown here are back up from unnamed tributary of Nonconnah Creek. No discharge from NE basin.

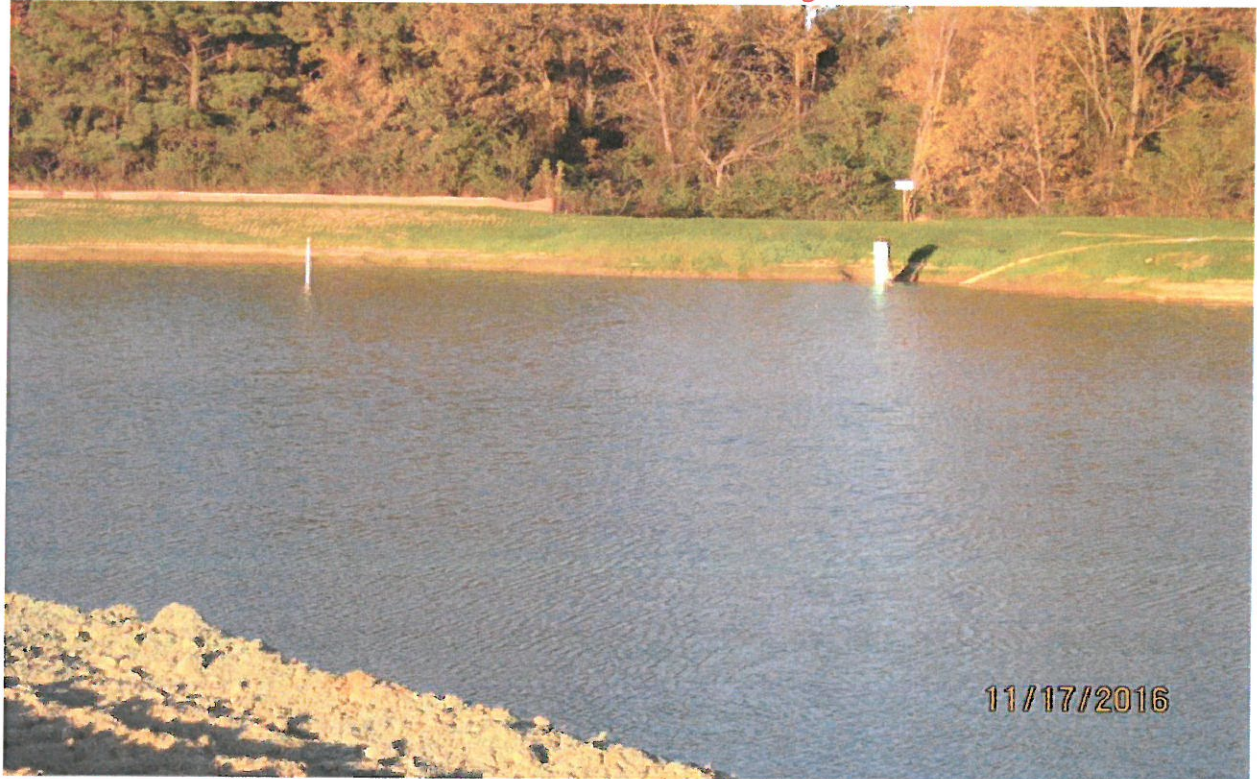
Photo 8 NE Basin showing stand pipe and depth gauge.

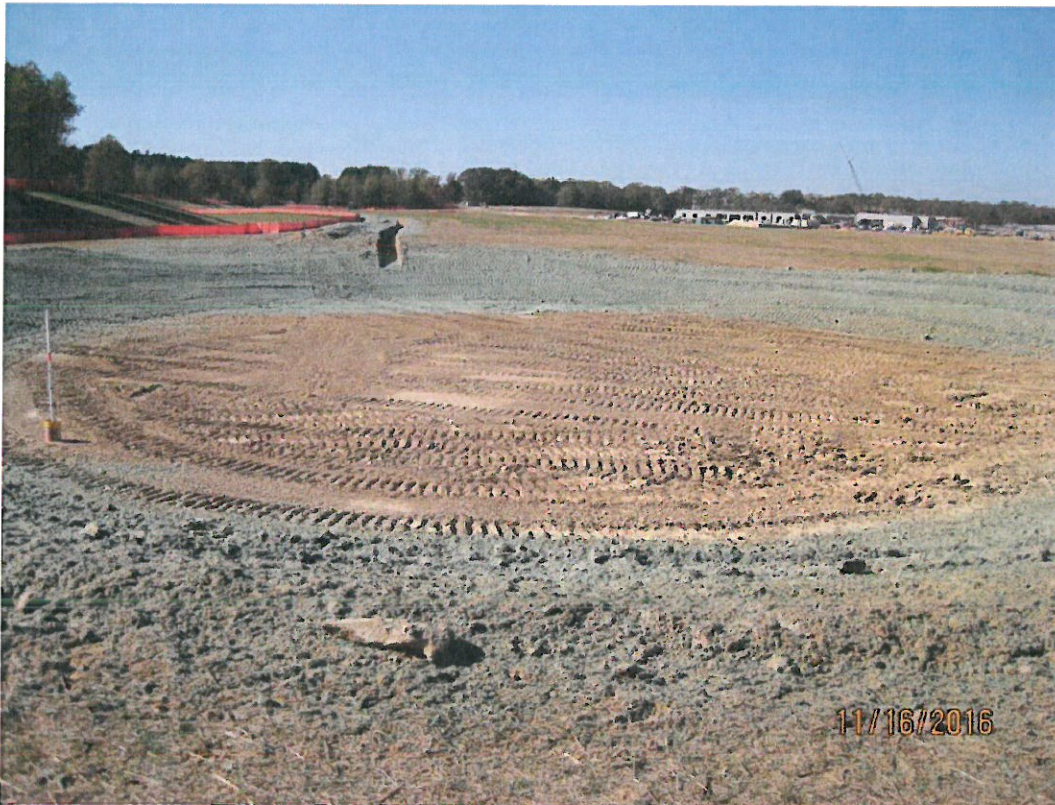
- The SE sediment basin had not been installed as shown on the permitted Erosion Control plans through the month of September for two reasons:
 - 1.) The area the SE basin was designed to collect storm water from had not been graded and the majority of the area remained undisturbed and drained to the north, allowing it to be captured in the NE basin.

- 2.) The permanent diversion ditch along the southern property line had not been fully excavated and connected to the un-named tributary. Therefore, it captured and held all the on-site and off-site water which drained to it and allowed the contractor to treat it as a sediment basin. The volume of water stored in the ditch was calculated based on the linear feet of ditch holding water allowing Reel Neet Erosion Control to calculate the amount of chemical flocculent to add.

- The southeast corner was out of compliance with the permit for a short transition between connecting the permanent drainage ditch along the southern property line with the un-named tributary and constructing the SE sediment basin, approximately two and one half weeks.

Photo 9 SE Sediment Basin with depth gauge and entrance of the diversion ditch. Side slopes have been hydroseeded.

- The SE sediment basin and depth gauge has been installed. In addition, a diversion ditch has been dug to control water and direct it to the SE basin. The material excavated from this ditch has been placed between the ditch and the sediment silt fence along the top of the permanent ditch along the southern property line. All material from the ditch and the ditch itself has been stabilized with hydro-seed.

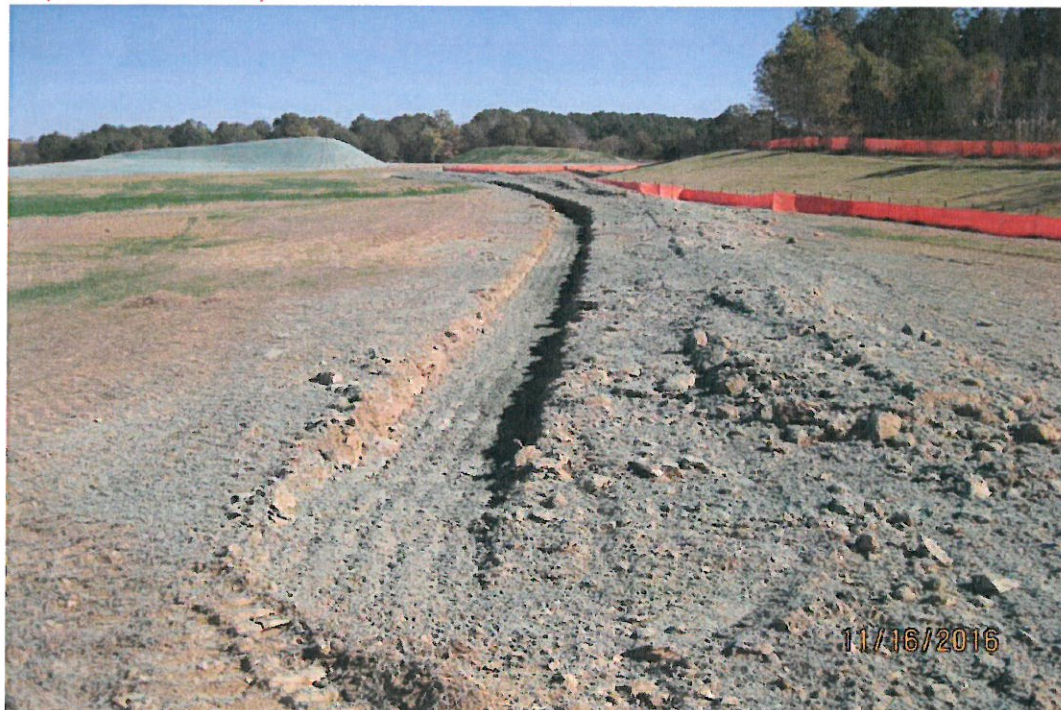
Photo 10 Beginning of diversion ditch to the SE Sediment Basin. Stabilized stockpile in the background.

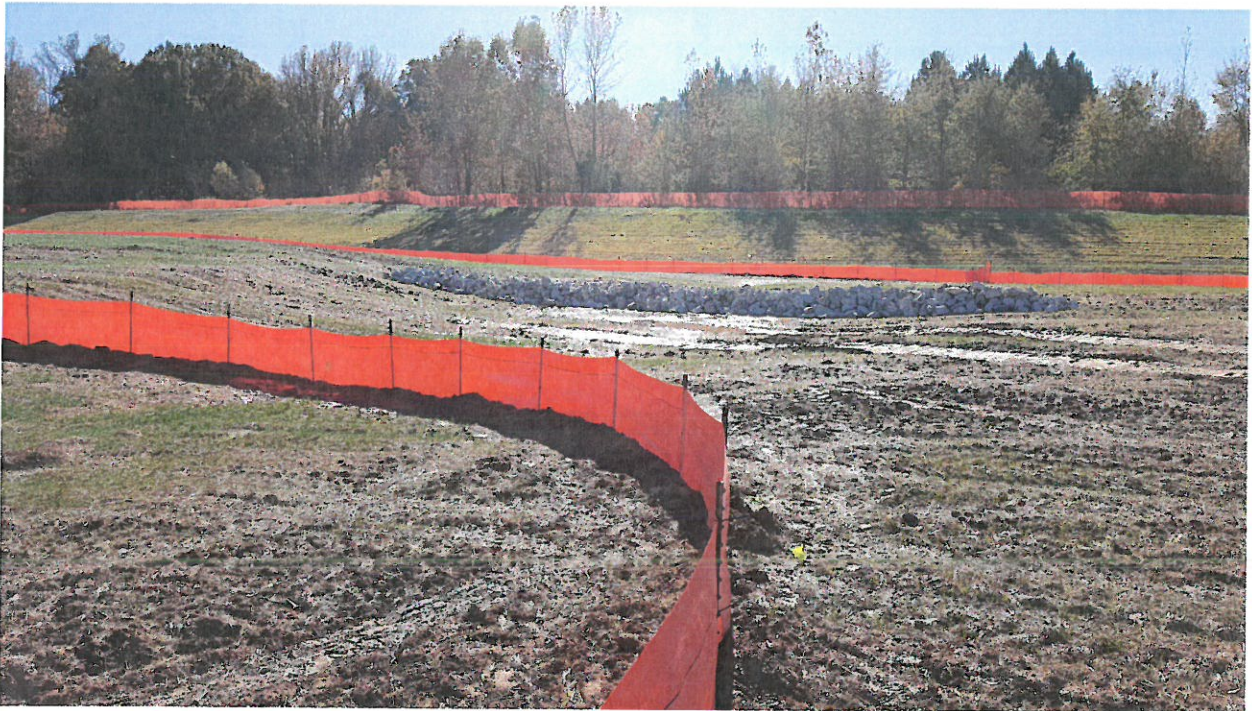
Photo 11 Area West of SE Basin. Silt fence and rock check dam are installed to control small area flow into main diversion ditch. Area stabilized with hydroseed.

- A rock check dam as well as angled silt fence have been installed just West of the diversion ditch to handle any waters that do not make it to the ditch.

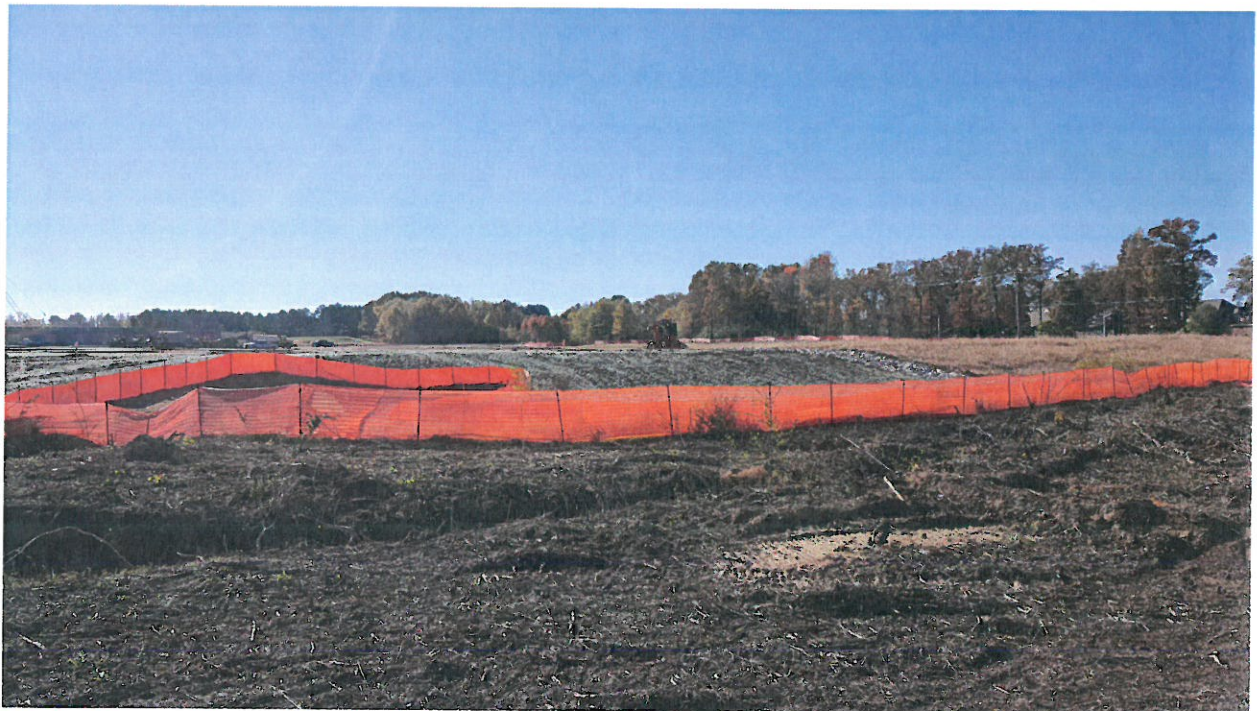
Photo 12 View of Shelby Drive road improvements just North of our silt fence along our property line. Clearing along Shelby Drive has been done under the Shelby Drive TDEC permit and is not a part of the Collierville High School NPDES permit.

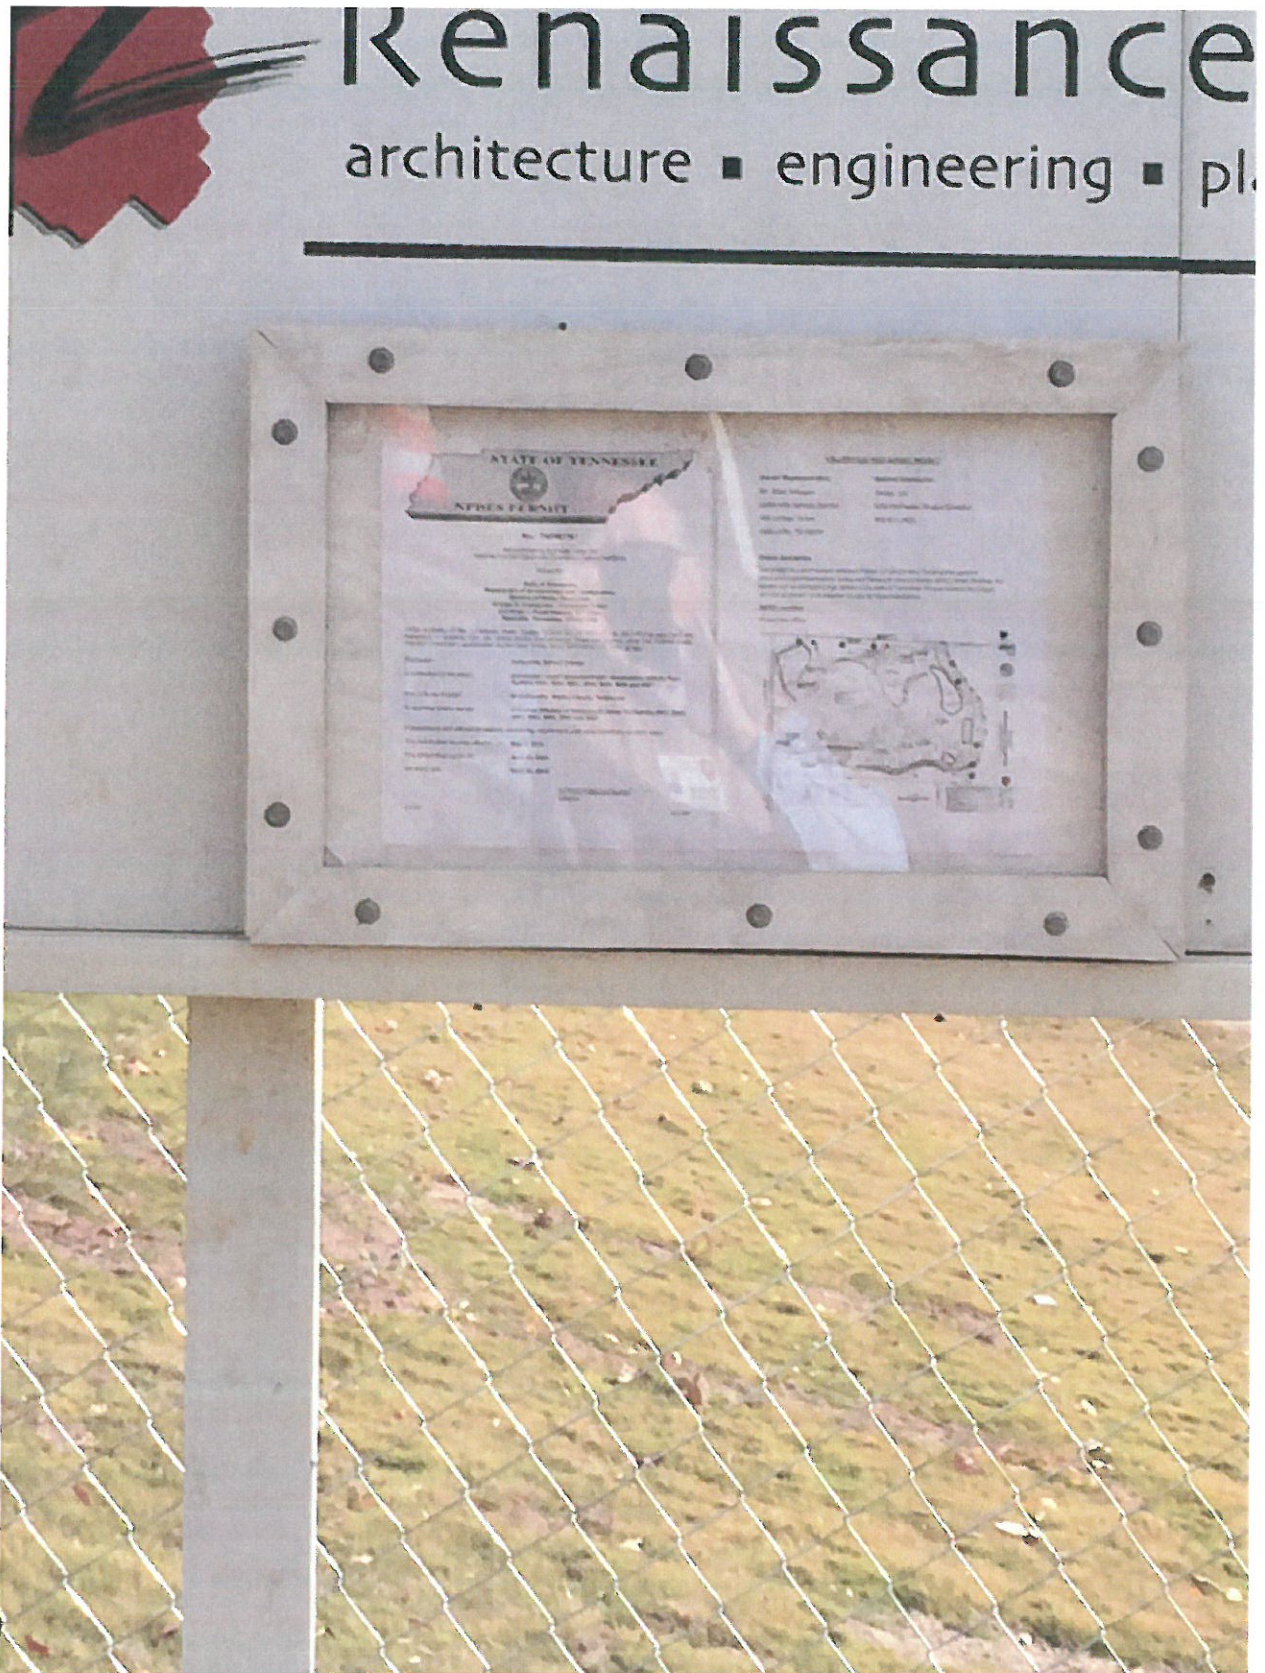
Photo 13 NPDES permit attached to construction sign at main entrance.

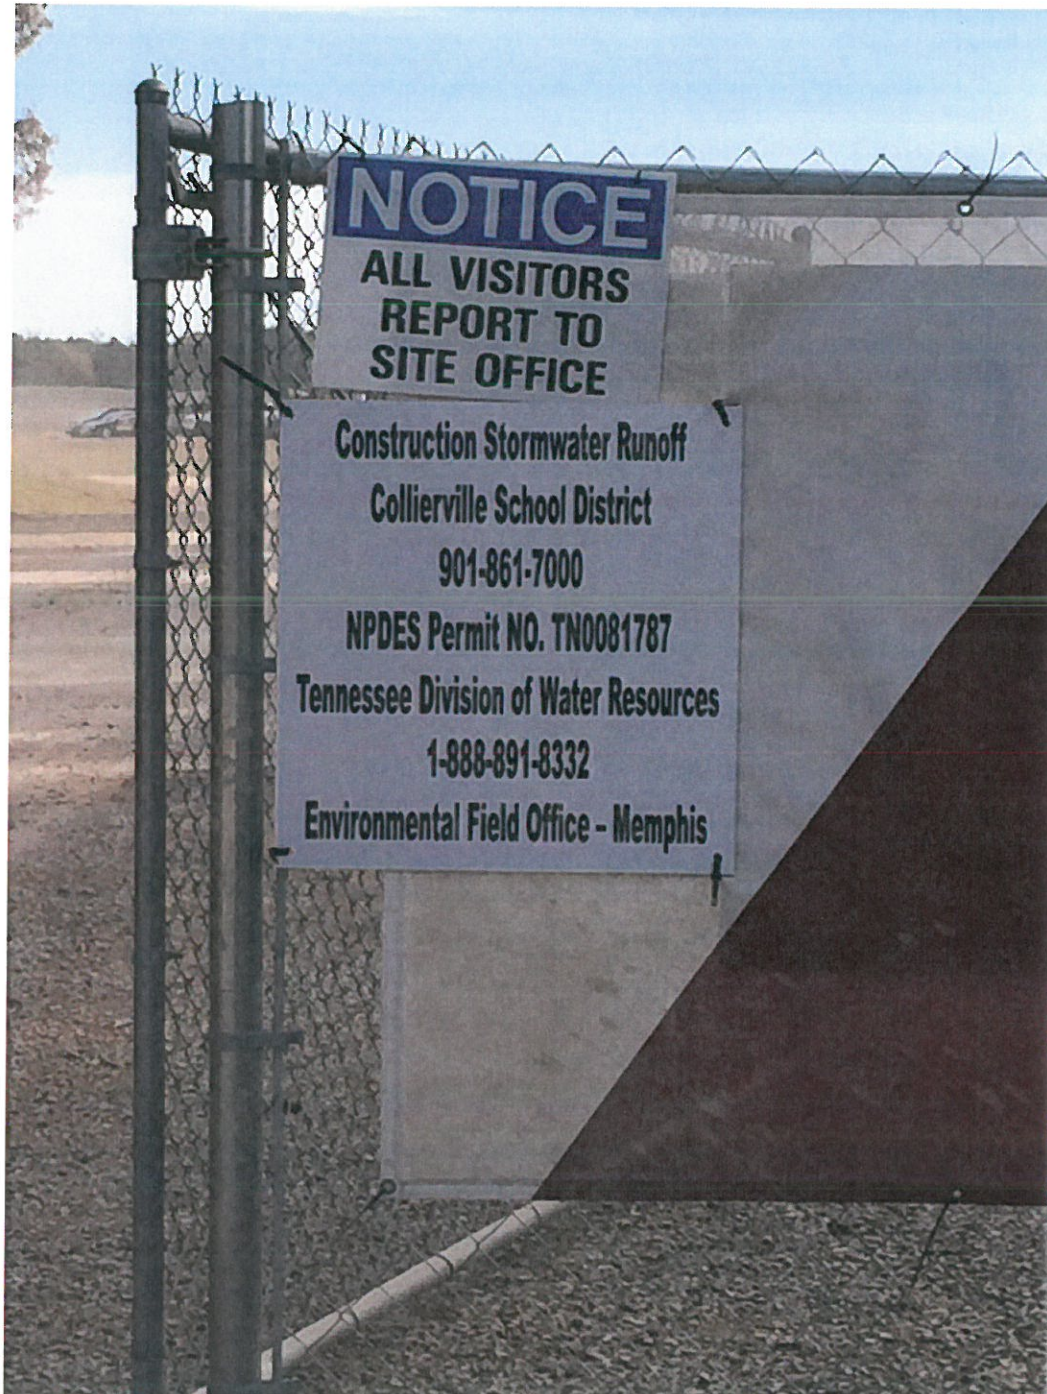
- Photo 14 One of three notices posted on our site. One is located on Shelby Drive even though Shelby Drive is closed for road improvements. Two notices are placed on each of the entrances off Sycamore Drive. The notice on the main entrance off Sycamore is attached to the fence near the entry road. This is the notice at the main entrance.
